Eco-House Foundation Project

As part of the Fall of 2009 Sustainability in Residences class, students identified projects that would contribute to the sustainability of the Eco-House. Among the proposals were solar hot water, rain catchment, organization and operations, building layout and floor plan, lighting and weatherizing plans. This project is the culmination of a Fall 2008 project entitled "Eco-House Basement Opportunity" that identified the need of PSU and Eco-House staff to address the structural integrity of foundation walls, as well as, related moisture and air quality issues. It was determined in the Spring of 2009 that the foundation walls of the Eco-House need to be replaced and construction was to be completed during the Summer of 2009. Upon partnering with ABODE Green Home Builders of Plymouth, NH, material choices and site design were selected.

The intent of construction done during the Summer of 2009 was to ensure the structural integrity of PSU's Eco-House for generations to come. This entailed repairing and replacing three main foundation walls, replacing the sill plate above foundation walls, replacing two main structural beams, repairing roof rafters and bra

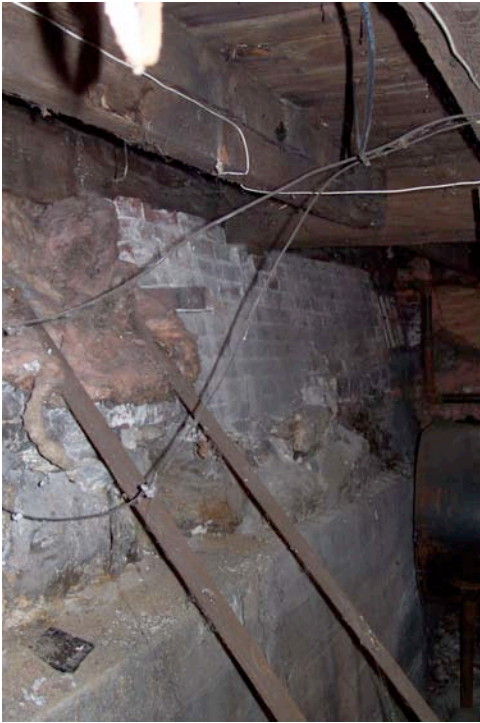
Why the FOUNDATION?

Pre-existing conditions in the basement of the Eco-House demonstrated water and moisture in the air caused building materials to deteriorate from the inside. This is supported by the evidence of dry rot on original support beams, floor joists, and other wooden boards in the basement. Additionally, moisture in basement air caused metal pipes and tanks to rust. The source of the problem water originated from surface and ground water entering through cracks and holes in foundation walls. Water would run off of the uphill slope and pass through foundation walls, where it would remain until surrounding moisture conditions would change. The source of problem water also entered the enclosed space

of the basement by means of air movement and infiltration through gaps and cracks in building materials. This created humidity issues and lead to the development of mold and fungus, both of which cause building materials to decay and health issues for people.

Original foundation walls were constructed from large and small rocks, bricks and granite slabs. These materials were pieced together with a mixture of mortar that deteriorated over the years due to its original quality, amount used, and the presence of water. Its deterioration allowed for the further entrance of water and air, the settling of the building upon a structurally compromised foundation, and further decay of building materials. These conditions required immediate attention and were the focus of work done during the Summer of 2009.

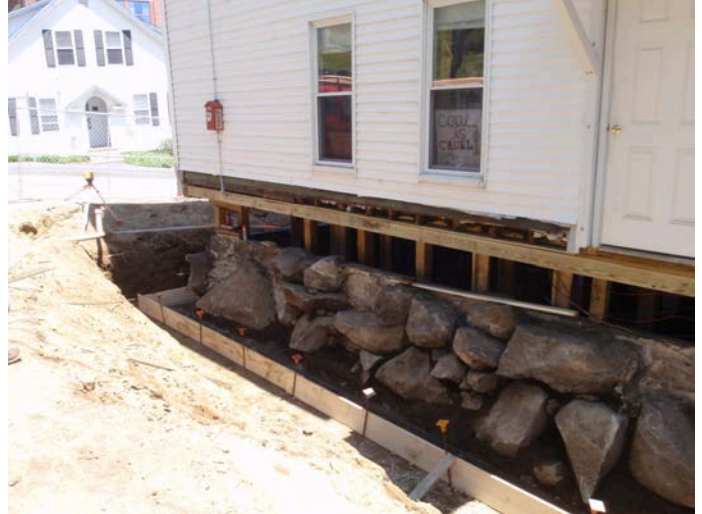
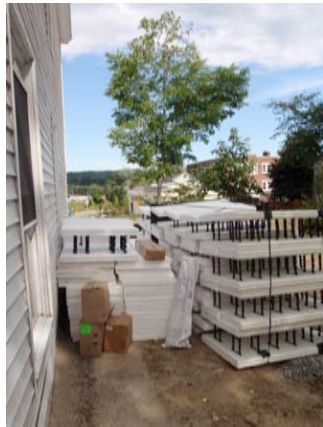
Existing conditions reveal that a more recent concrete slab poured on the interior basement floor and up foundation walls held in place many large, oddly shaped boulders. Removal of the boulders and concrete would have compromised the basement floor and added to time, labor, waste, and removal costs. Insulated Concrete Forms (ICFs), therefore, were assembled along the perimeter of the remaining portion of the original foundation.

Instead of using and removing wooden forms as in traditional concrete foundations, ICFs remain in place.

ICFs are a series of interlocking hollow foam blocks that snap together to create a formwork that doubles as insulation. The rigid foam formwork insulate the foundation walls on the inside and outside, dramatically reducing energy loss through uninsulated walls. Additionally, ICFs are easy to assemble and allow the concrete to cure under optimal temperature and moisture conditions.

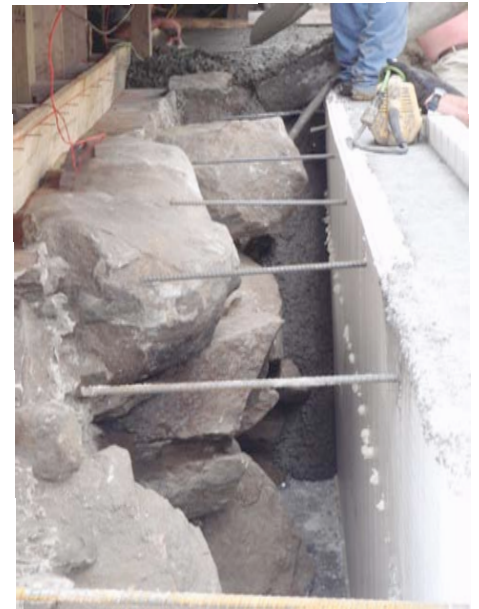
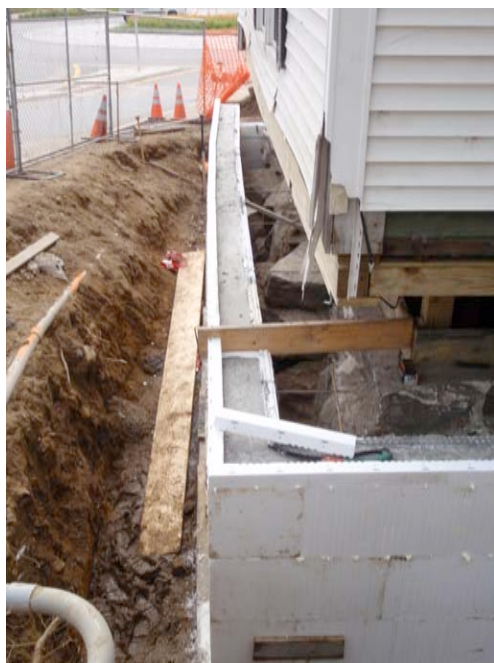
After building the ICF wall, concrete was poured in the gap between the ICFs and the protruding boulders. This resulted in the base of the foundation wall to have dimensions of 3ft by 4ft and 3ft by 5ft, due to the difference in grade of slope. ICFs were then constructed from this base to meet the sill plate.

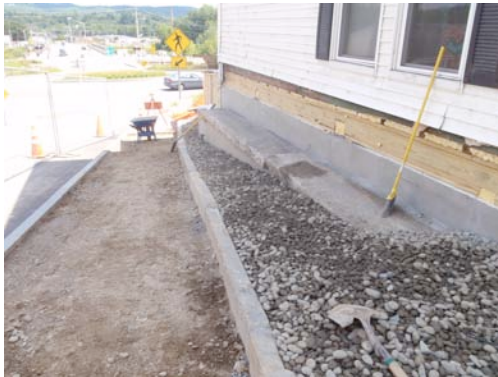
The original basement was most likely used as a root cellar to store food before refrigerators. Moisture and air migration were not a major issue when this space was intended for food storage. The addition of concrete came some years after the foundations initial construction and is thought to be an attempt to prevent moisture and water from entering through walls.

To limit water infiltration through foundation walls, it is critical to divert surface and subsurface water away from the building. This was achieved through a combination of methods:

Small stones were placed on the perimeter of building to encourage drainage down and away from the building, as well as, to prevent the accumulation of surface water nearby the top of the foundation walls.

A waterproof layer was applied to the exterior of the ICF in order to form a barrier that water should not enter.

A perimeter drain was installed around the bottom of foundation walls to encourage soil drainage and reduce the amount of water next to subsurface walls. This consisted of interconnected perforated piping installed below the level of the footings of the foundation and directs water to a

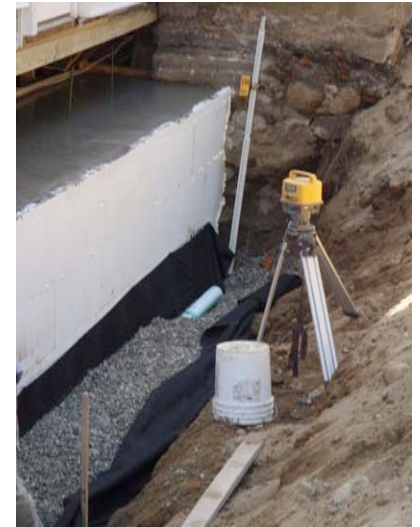
lower point away from the building. The perforated piping was covered with filter fabric to prevent clogging of holes and was surrounded by clean gravel and crushed stone to encourage drainage. The discharge of a perimeter drain may be connected into a storm water system in a town or may simply empty to a down slope location. At the Eco-House, the pipes of the perimeter drain were connected to an engineered drainage system that functions to divert, collect, and slow down surface and ground water. A elevated drain was installed in the center of the catch-

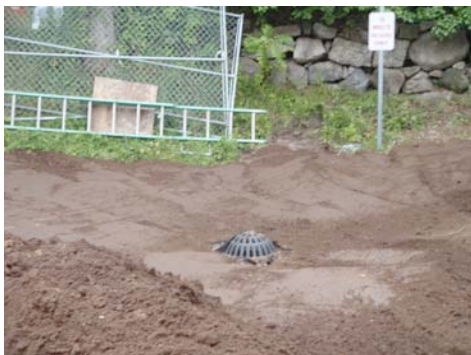
ment area that connects to the public storm water system in the event of a large amount of water.

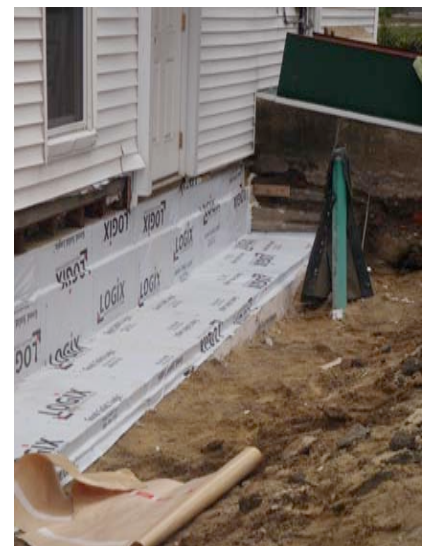
Keeping water away from the foundation is the key to water management. The presence of water in the winter months contributes to frost and foundation movement due to the expansion of frozen water. A water managed foundation is designed to move water away from and prevent the accumulation of water next to foundation walls. This was achieved at the Eco-House during work completed during the Summer of 2009.
